Some Failure Analysis Case Histories in Galvanized Steel Products

Dr. Zamanzadeh and Ed Larkin Matco Associates, Pittsburgh, PA

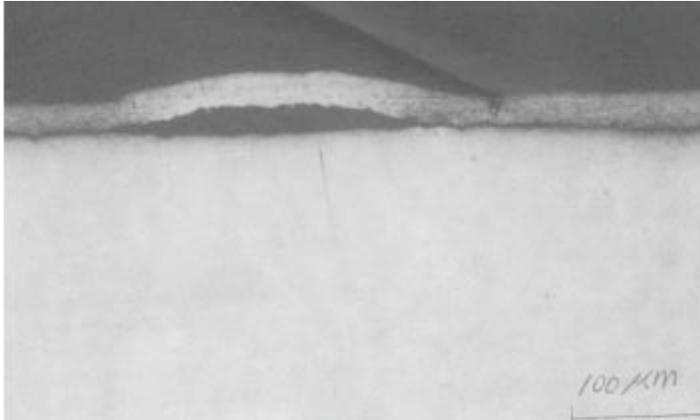
Transverse sections through the galvanized steel in the blistered areas were prepared for subsequent metallographic inspection. In the as-polished condition, the blisters were observed as small arches in the coating with complete separation occurring at the zinc-steel interface (Fig. 1). At high magnifications, small gray inclusions were observed on the steel surface within the cavity (Fig. 2). The inclusions were examined using a scanning electron microscope equipped with an energy dispersive X-ray spectrometer. Only iron was observed. The equipment cannot detect the presence of elements in the first row of the periodic table such as carbon, oxygen, nitrogen, etc. Based upon the appearance of the inclusions, and the absence of any elements other than iron, the inclusions are most likely iron oxide.

Figure 1: Photograph at 200x showing a blister under the galvanized coating as polished.

The blisters in the galvanized coating appear to have been caused by gas accumulation at the interface between the steel and the zinc coating. Iron oxide inclusions were observed within the blister cavities. The following mechanism is responsible for the blistering problem: (1) the as-received steel strip probably was incompletely pickled, which left iron-oxide scale at small isolated locations; (2) during pickling and later annealing, hydrogen was absorbed by the steel; (3) during galvanizing, the heat from the molten zinc caused the hydrogen to diffuse out of the steel; (4) at locations where surface oxides existed, the atomic hydrogen was able to recombine to form diatomic molecular hydrogen gas that raised the surface of the coating, forming the observed blisters.

To eliminate this problem, it was suggested that the surface oxides be eliminated completely. This will not prevent hydrogen absorption but should prevent the formation of gas blisters when the hydrogen diffuses out of the steel during galvanizing.

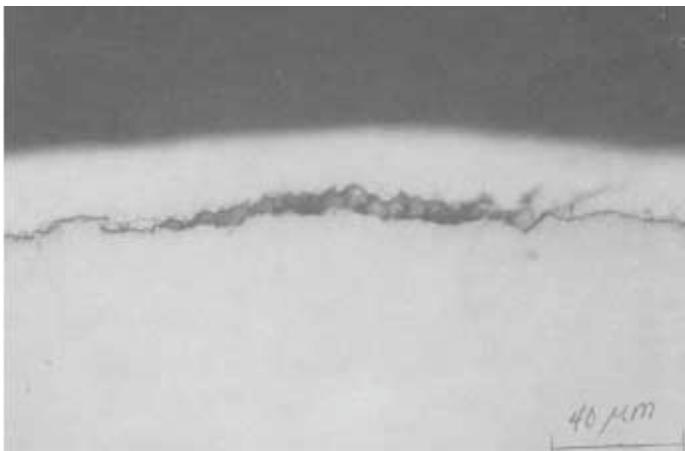
Figure 2: Photograph at 500x showing scale particles within a blister as polished.
