Gas Distribution Pipe Explosion

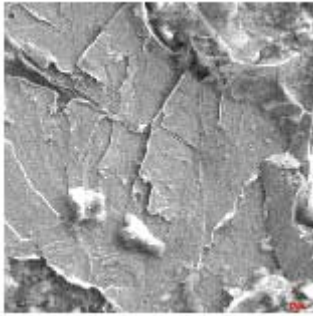
An unprotected schedule 40 carbon steel pipe ruptured beneath the surface of an essential roadway. The pipe was visibly corroded on its exterior surface. When cut open, black colored deposits but no underlying corrosion was observed on the inside diameter surface of the pipe. Further mechanical damage and abrasion were exhibited on the pipe exterior, especially at a hole several feet away from the fracture. Noncompliance was suspected and an immediate failure investigation was deemed necessary to assign financial responsibility.

The pipe was observed to have failed in its thread roots immediately adjacent to a pipe coupling. To examine the fracture area in greater detail, a sample was prepared for metallurgical examination. The non-corroded areas of the fracture surface were found to exhibit a brittle cleavage mode of failure when subjected to SEM analysis. In brittle failures, small cavities and cracks are initially formed by slip; then, as loading continues, the cracks initiate new cracks in adjacent grains along the cleavage plain similar to the branching of a leaf. In this case, the fracture began at the thread roots spreading towards the center of the pipe in a chevron shaped pattern.

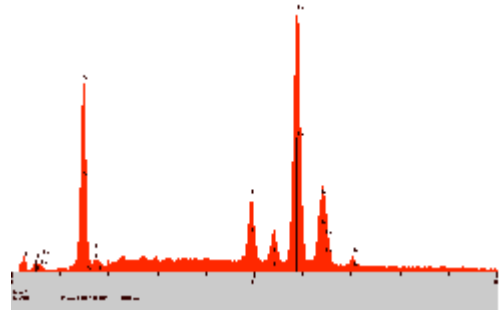
Further metallurgical examination detected several internal and external inclusions with respect to the failed pipe. An unusually high amount of nonmetallic inclusions including manganese sulfides and aluminates were discovered throughout the pipe material. Non-metallic inclusions were also discovered along the weld seam region. The presence of these inclusions suggested low quality steel, a steel more prone to brittle failure.

rupture at the adjoining pipe coupling as a result of these conditions. It was recommended that the soil subsidence problem be addressed and remedied.
