## Task: Vibration Measurement and Dynamic Balancing of Hydraulic Motor Test bench:

### Vibration Measurement and Dynamic Balancing

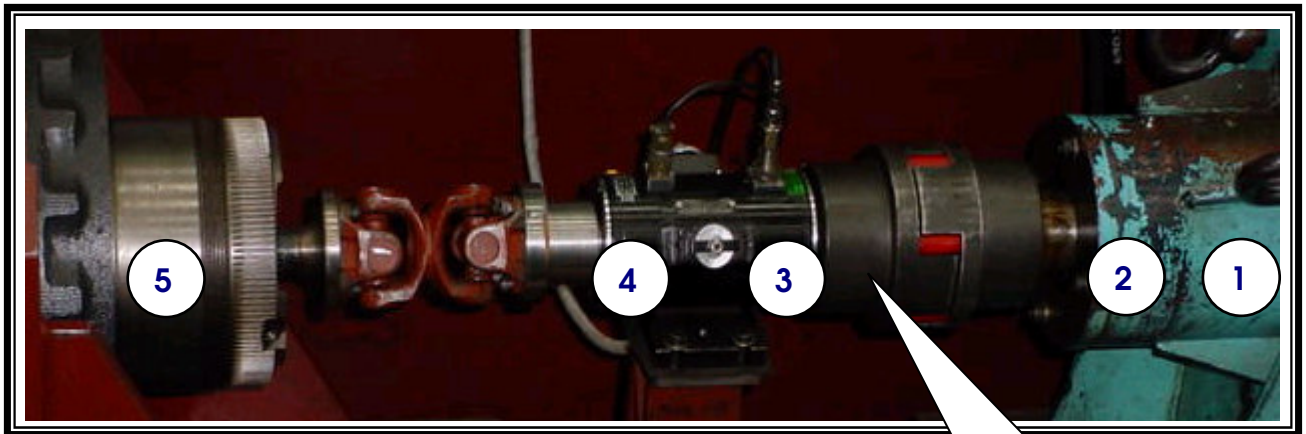
**MACHINE BLOCK DIAGRAM**

Mass addition done here

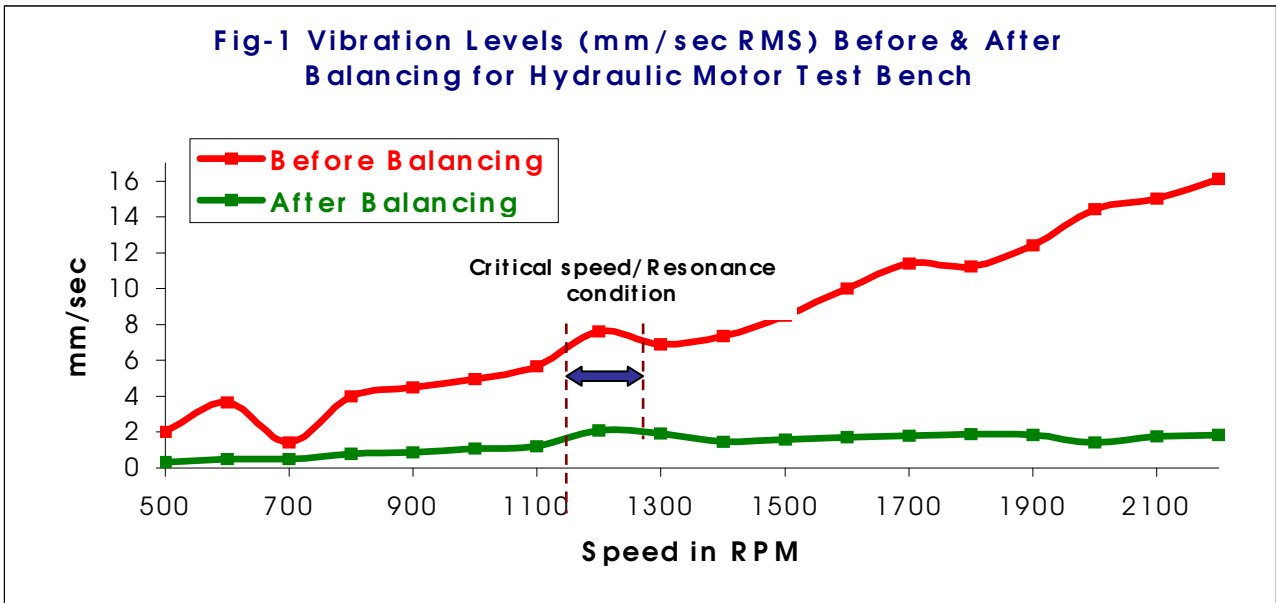
**Fig-1 Vibration Levels (mm/sec RMS) Before & After Balancing for Hydraulic Motor Test Bench**

Measurement Point	Speed in rpm	Vibration severity level in mm/sec (rms.)		Correction in gm-mm
		Before Balancing	After Balancing	
		At 1 x rpm	At 1 x rpm	
Location # 2	2200	<b>6.45</b>	<b>0.45</b>	2100
Location # 3		<b>16.13</b>	<b>1.85</b>	5250

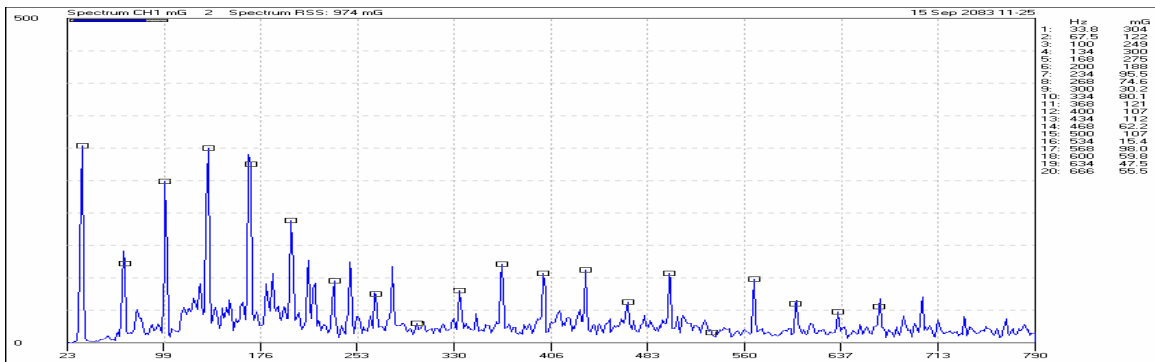
**Low frequency spectrum taken at location # 3. (Fig-5)**

- It was observed from the measurement that there is a resonance condition at around 1200 rpm where the natural frequency of the system is matching with the running frequency of the unit and the vibration levels are reaching the alarm limits. Hence it is suggested not to run the test bench at the above-mentioned speed.
- The entire test bench is mounted on a hollow frame structure, which is very weak in nature and no foundation bolts are provided. Hence it is not in a position to damp the vibrations at high speed (2200 rpm). Therefore it is suggested to make the system more rigid and stiff by doing proper grouting and providing antivibration pads at the base.
- Check for any rotating looseness/foundation bolts looseness as the running frequency harmonics are observed in the low frequency spectrum at location# 3 (Refer Fig-5)
