# Task: Vibration Measurement and Dynamic Balancing of Hydraulic Motor <u>Test bench:</u>

#### Vibration Measurement and Dynamic Balancing

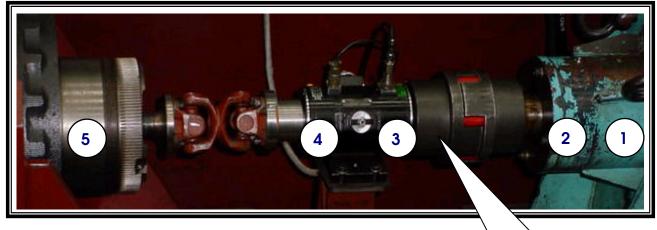
MACHINE BLOCK DIAGRAM

Mass addition done here

Measurement Location

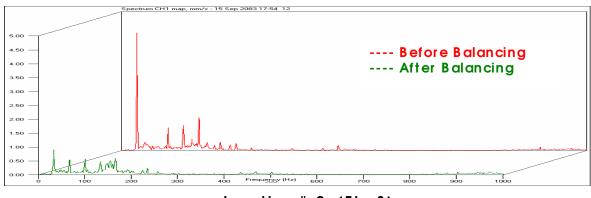
Location # 2, (Fig-3)

Measurement Point	S peed in rpm	Vibration severity level in mm/sec (rms.)		Correction
		Before Balancing	After Balancing	Correction in gm-mm
		At 1 x rpm	At 1 x rpm	
Location # 2	2200	6.45	0.45	2100
Location # 3		16.13	1.85	5250

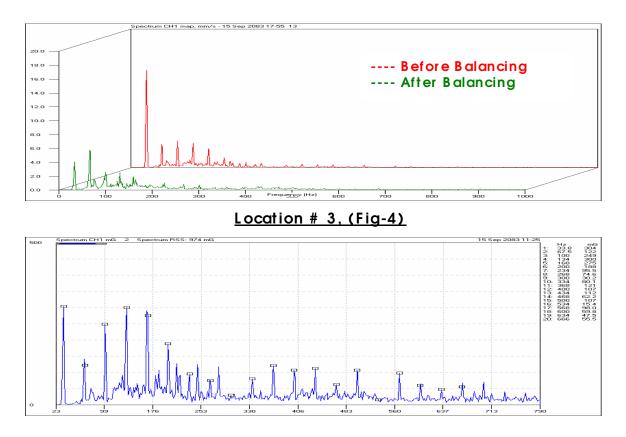
### Low frequency spectrum taken at location # 3. (Fig-5)

- It was observed from the measurement that there is a resonance condition at around 1200 rpm where the natural frequency of the system is matching with the running frequency of the unit and the vibration levels are reaching the alarm limits. Hence it is suggested not to run the test bench at the above-mentioned speed.
- The entire test bench is mounted on a hollow frame structure, which is very weak in nature and no foundation bolts are provided. Hence it is not in a position to damp the vibrations at high speed (2200 rpm). Therefore it is suggested to make the system more rigid and stiff by doing proper grouting and providing antivibration pads at the base.
- Check for any rotating looseness/foundation bolts looseness as the running frequency harmonics are observed in the low frequency spectrum at location#3 (Refer Fig-5)
