Resonance Analysis

A Vertical Pump Case History

Ali M. Al-Shurafa
 Email: ashurafa[remove.all.in.and.brackets]@gawab.com
 Jubail Industrial College
 Saudi Arabia

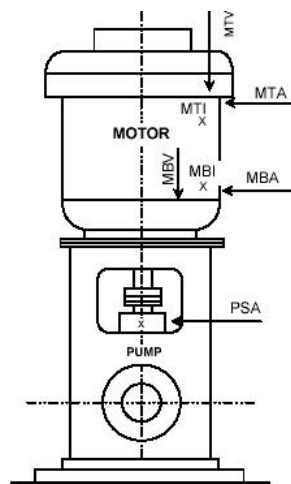
Figure 1 Schematic of the machine

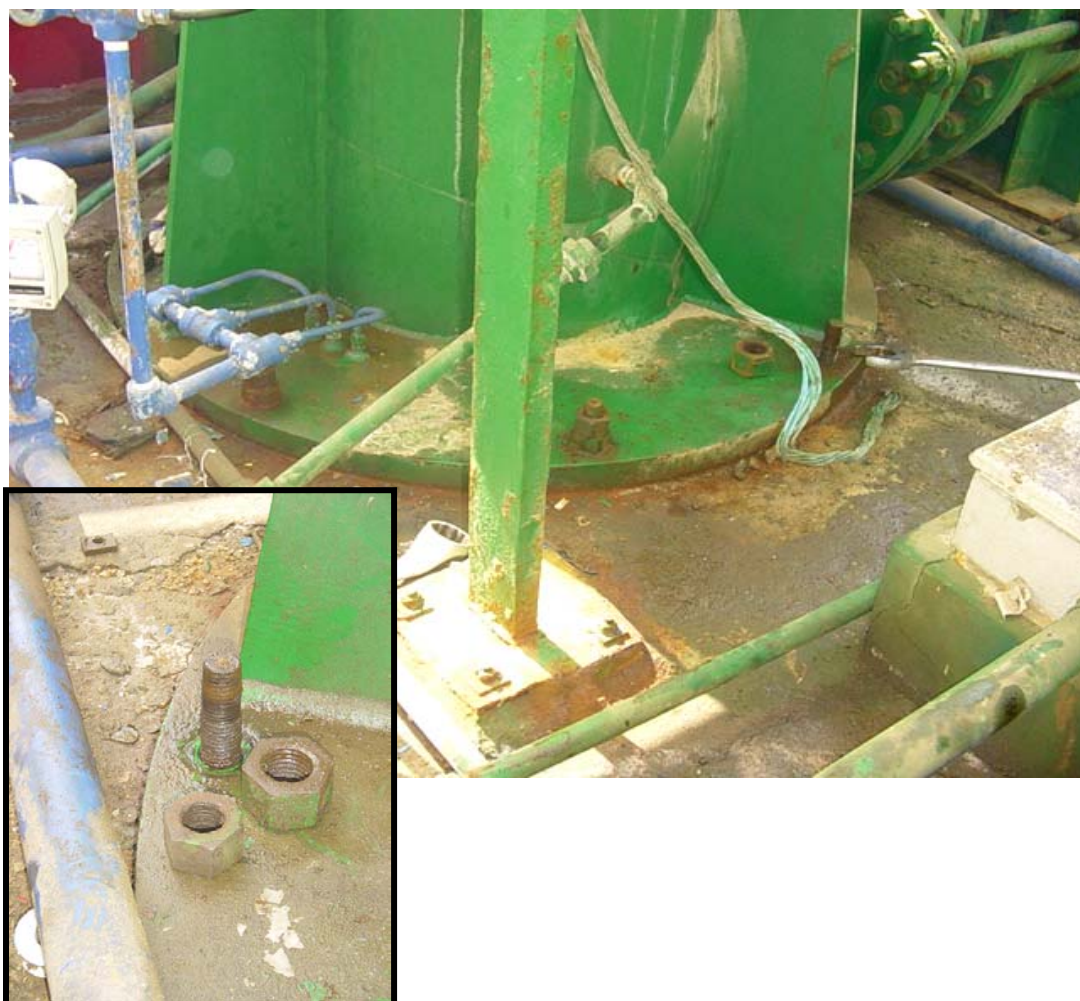
Figure 6 Physical deterioration in the foundation, bolts and nuts

The corrective action was to raise the natural frequency above the running speed by identifying the location of the low stiffness parts of the structure. These locations are typically the "joints" like the motor-motor stool bolts and the motor stool-ground studs. By tightening the bolts and studs, the problem was found to be corroded and loose studs and nut as can be seen from the picture (Figure 6). A temporary solution was to replace the studs and nut while the permanent solution was recommended to perform a civil work in the concrete foundation. The foundation was physically deteriorated because of the more water contamination and settlement than sister machines in the same. After replacement, vibration dropped to about 15 % of the previous readings.
