Resonance Analysis

A Vertical Pump Case History

Ali M. Al-Shurafa
 Email: ashurafa[remove.all.in.and.brackets]@gawab.com
 Jubail Industrial College
 Saudi Arabia

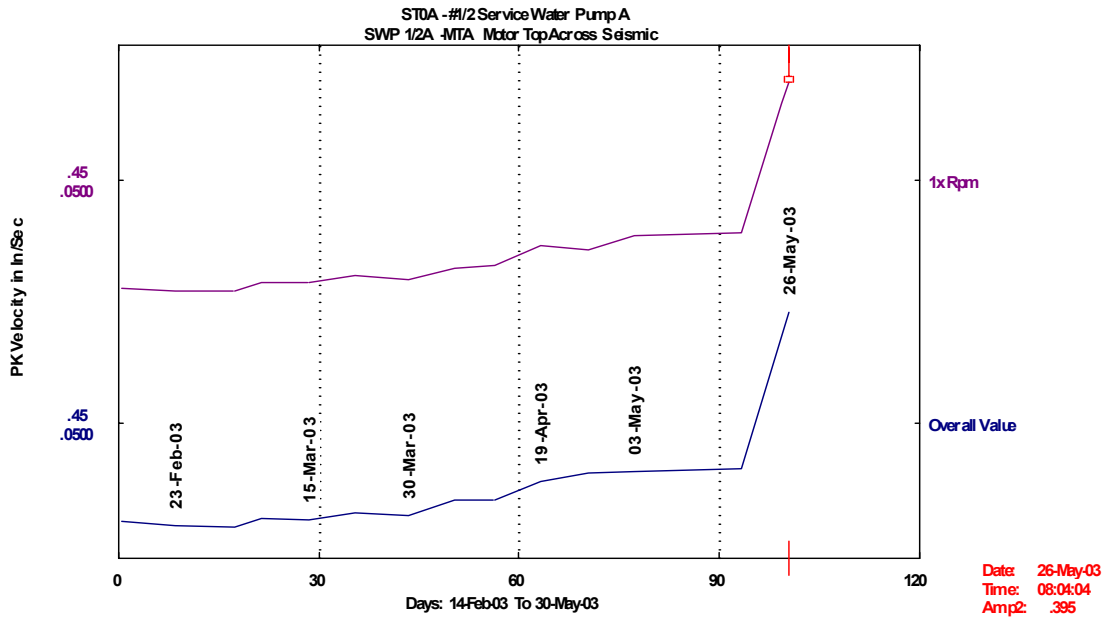
Table 1 summarizes the unfiltered vibration reading on six points, as their locations are indicated in Figure 1. A trend of the highest vibration point (MTA) is given in Figure 2. From the trend it can be noticed that the majority of the vibration signal is synchronous (1x Rpm) vibration. This was confirmed also by corresponding spectrum of the same point in Figure 3.

Figure 2 Unfiltered and 1x vibration trend

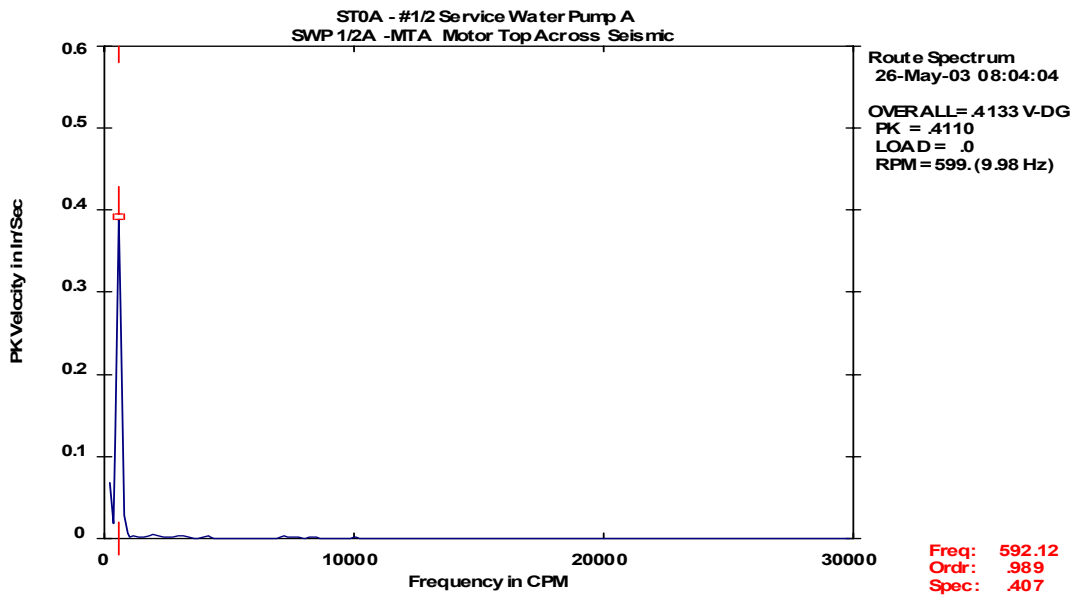
Figure 3 Vibration spectrum from routine survey

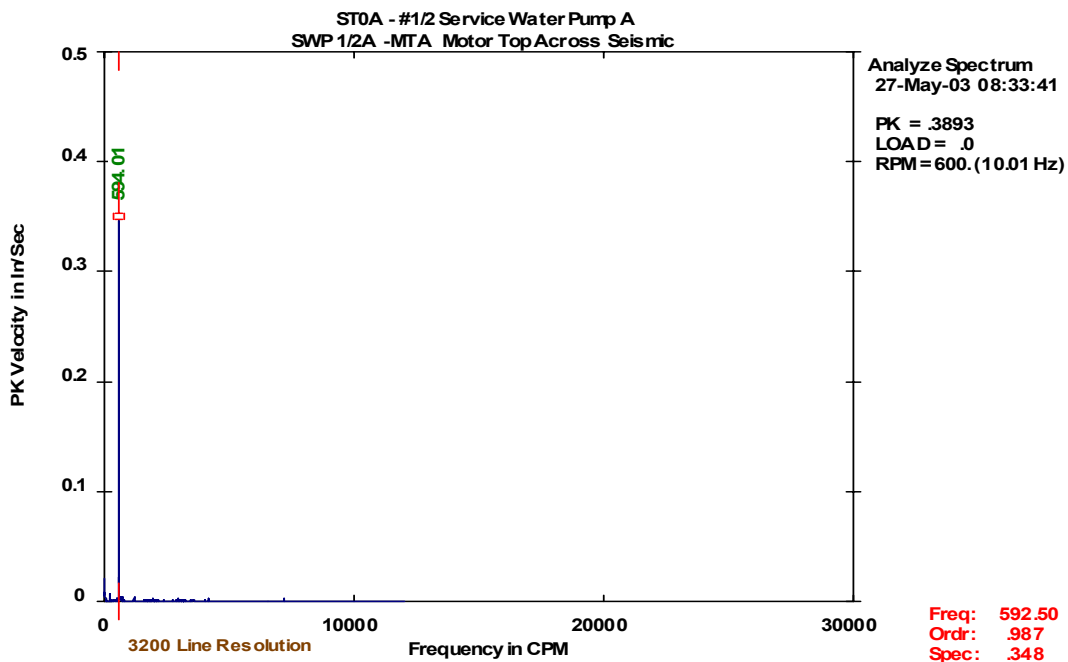
Vibration reading was collected on the monitor mode to check the stability of the signature and no abnormalities were noticed. To confirm the exact frequency at which the vibration is taking place and examine the existence of any other significant frequencies, a high resolution data was collected with 3200 lines, as shown in Figure 4. The resultant spectrum showed single amplitude at the running speed.

Figure 4 High resolution spectrum showing exact 1x vibration response

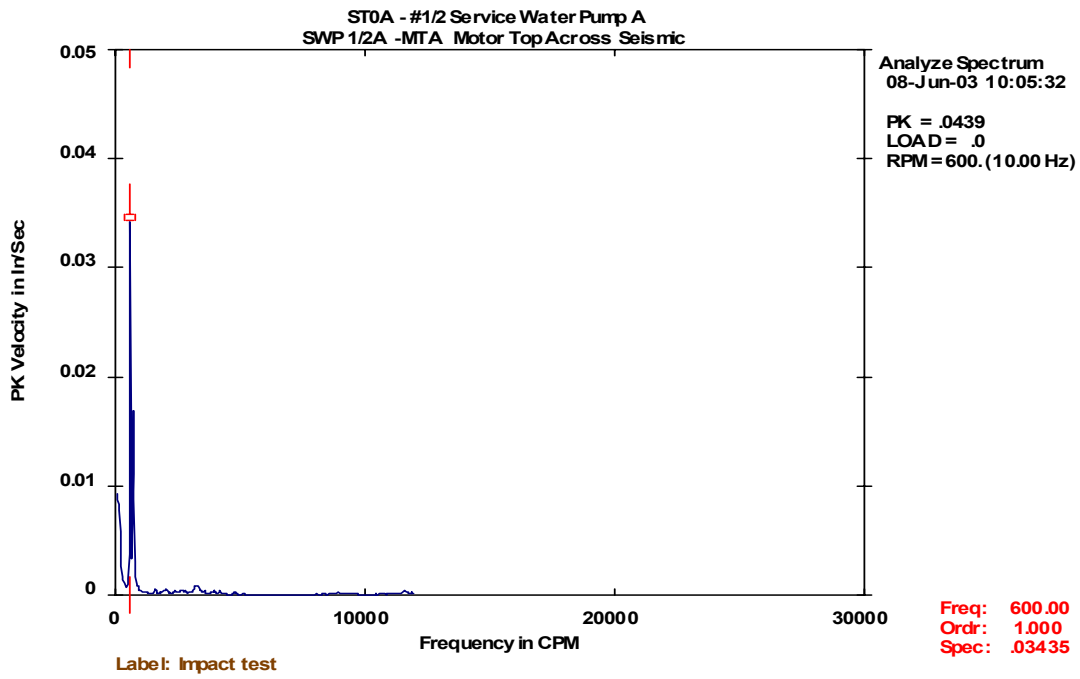
No abnormalities were found after the visual inspection and the impact test spectrum is given in Figure 5. It is very clear from the impact test that the structure natural frequency was coinciding on the running speed casing vibration amplitudes to magnify due to resonance. Engineering reports recorded that this pump after the current installation had a natural frequency of 700 cpm and cautioned that the natural frequency of the sister machines is higher (800 cpm). The conclusion that could be drawn is that the stiffness of the structure was initially low and gradually decreased and pushing the natural frequency down closer to the running speed 600 rpm, as described by the basic formula:

Figure 5 Spectrum of impact test showing 600 cpm natural frequency

The corrective action was to raise the natural frequency above the running speed by identifying the location of the low stiffness parts of the structure. These locations are typically the "joints" like the motor-motor stool bolts and the motor stool-ground studs. By tightening the bolts and studs, the problem was found to be corroded and loose studs and nut as can be seen from the picture (Figure 6). A temporary solution was to replace the studs and nut while the permanent solution was recommended to perform a civil work in the concrete foundation. The foundation was physically deteriorated because of the more water contamination and settlement than sister machines in the same. After replacement, vibration dropped to about 15 % of the previous readings.

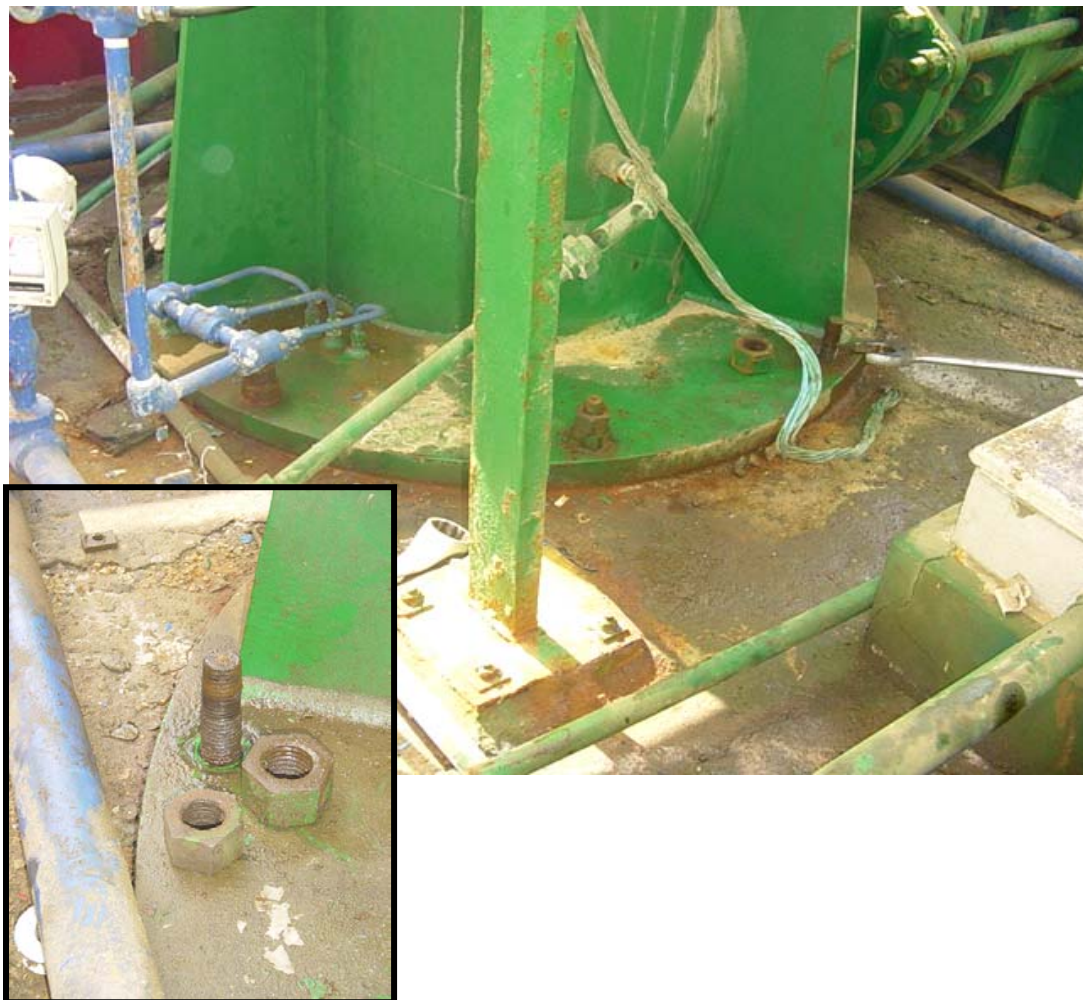
Figure 6 Physical deterioration in the foundation, bolts and nuts
