Resonance Analysis

A Vertical Pump Case History

Ali M. Al-Shurafa
 Email: ashurafa[remove.all.in.and.brackets]@gawab.com
 Jubail Industrial College
 Saudi Arabia

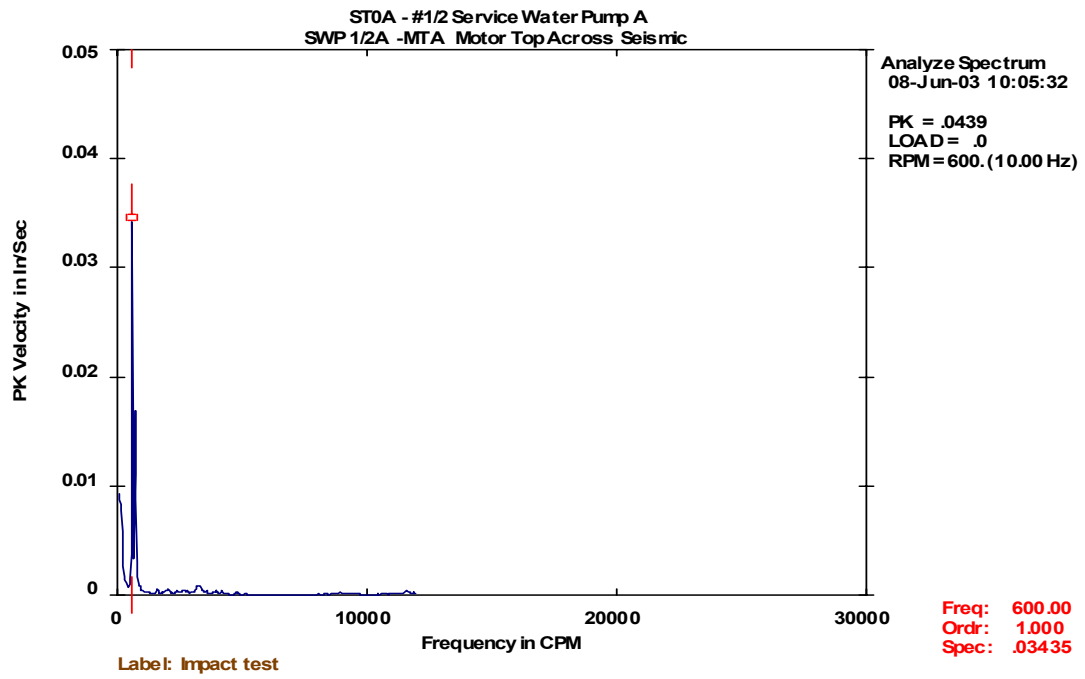
No abnormalities were found after the visual inspection and the impact test spectrum is given in Figure 5. It is very clear from the impact test that the structure natural frequency was coinciding on the running speed casing vibration amplitudes to magnify due to resonance. Engineering reports recorded that this pump after the current installation had a natural frequency of 700 cpm and cautioned that the natural frequency of the sister machines is higher (800 cpm). The conclusion that could be drawn is that the stiffness of the structure was initially low and gradually decreased and pushing the natural frequency down closer to the running speed 600 rpm, as described by the basic formula:

Figure 5 Spectrum of impact test showing 600 cpm natural frequency

The corrective action was to raise the natural frequency above the running speed by identifying the location of the low stiffness parts of the structure. These locations are typically the "joints" like the motor-motor stool bolts and the motor stool-ground studs. By tightening the bolts and studs, the problem was found to be corroded and loose studs and nut as can be seen from the picture (Figure 6). A temporary solution was to replace the studs and nut while the permanent solution was recommended to perform a civil work in the concrete foundation. The foundation was physically deteriorated because of the more water contamination and settlement than sister machines in the same. After replacement, vibration dropped to about 15 % of the previous readings.

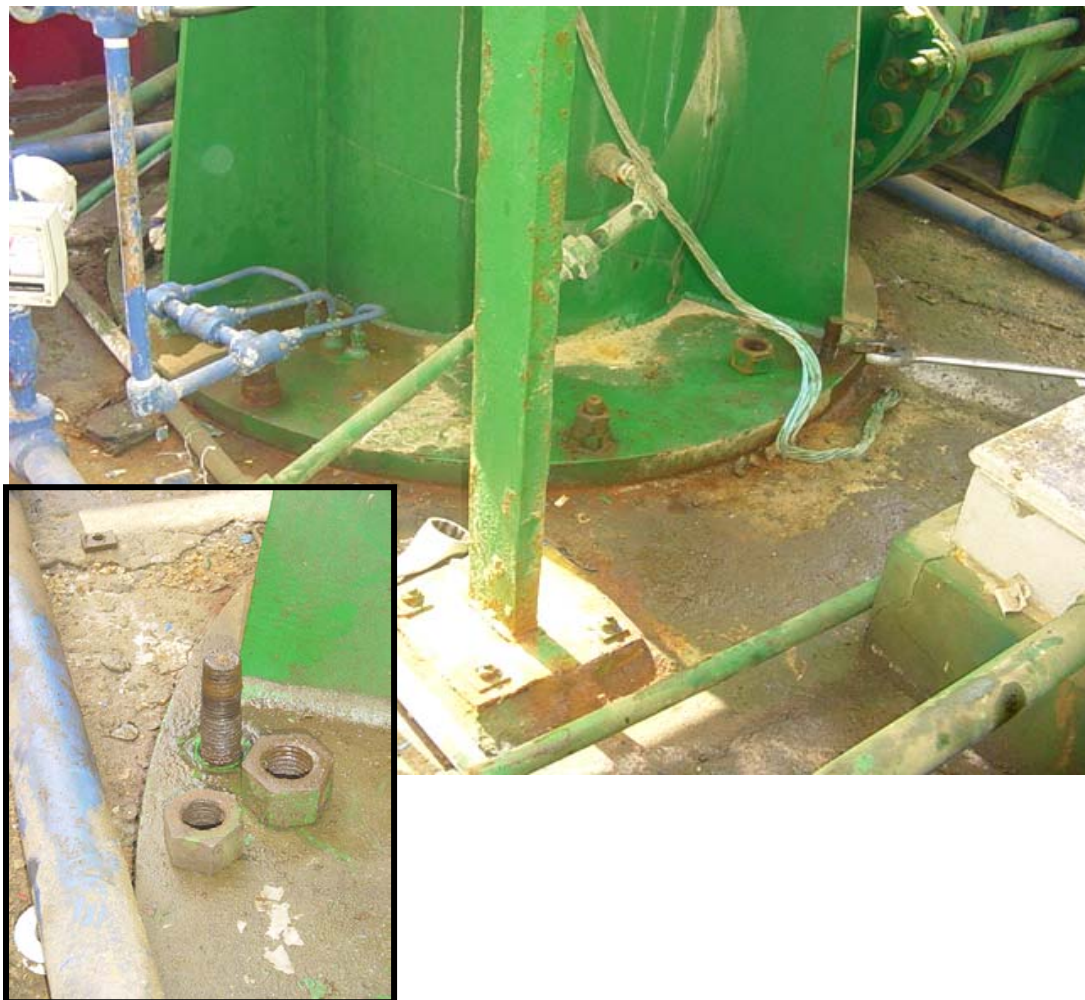
Figure 6 Physical deterioration in the foundation, bolts and nuts
