Shaft Eccentricity and Bearing Forces

**Central Maintenance Department
(Vibration Section)
EQUATE PETROCHEMICAL COMPANY
KUWAIT**

Case

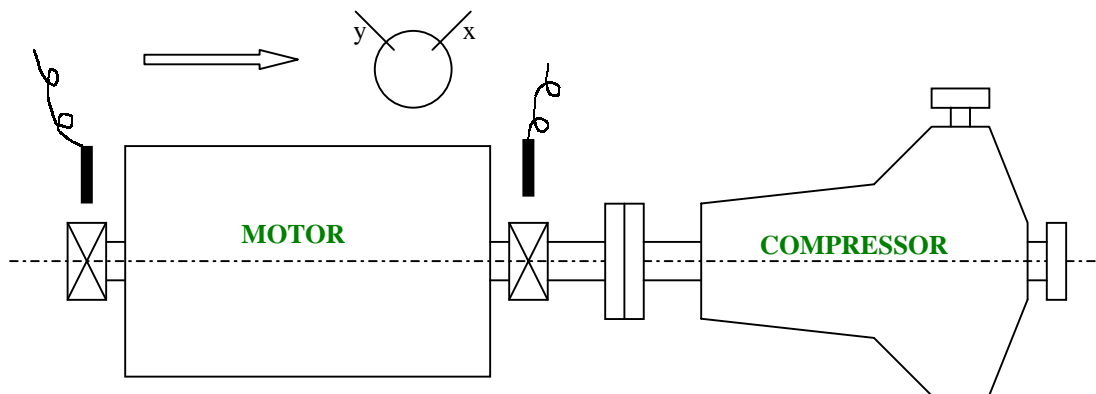
The Single stage overhung, AC Compressor, driven by 6705HP motor, operates at 2995 rpm. The Compressor handles Ethylene gas with inlet capacity 29455ACPM at a total head of 18.6 psia. The motor operates above its first system critical (2400 rpm) and is supported on pivoted shoe journal bearings.

Fig 1. Line-2, AC Compressor Machine train

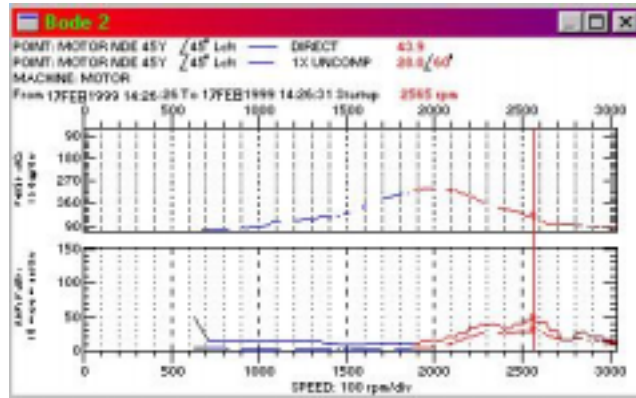
The Machine started off normally and the vibration amplitudes during the critical speed and at the running speed remained within the limit. The maximum vibration level observed at the Motor outboard was 1.85mils(47microns), at the critical speed. The vibration level at the rated speed, immediately after start-up, settled down to 35microns, which was high as compared to the normal start-ups.

The Bode plot shows split resonance on both the bearings. No sub synchronous and non-synchronous components were detected.

Fig 2. Bode plot of Motor outboard Y-probe

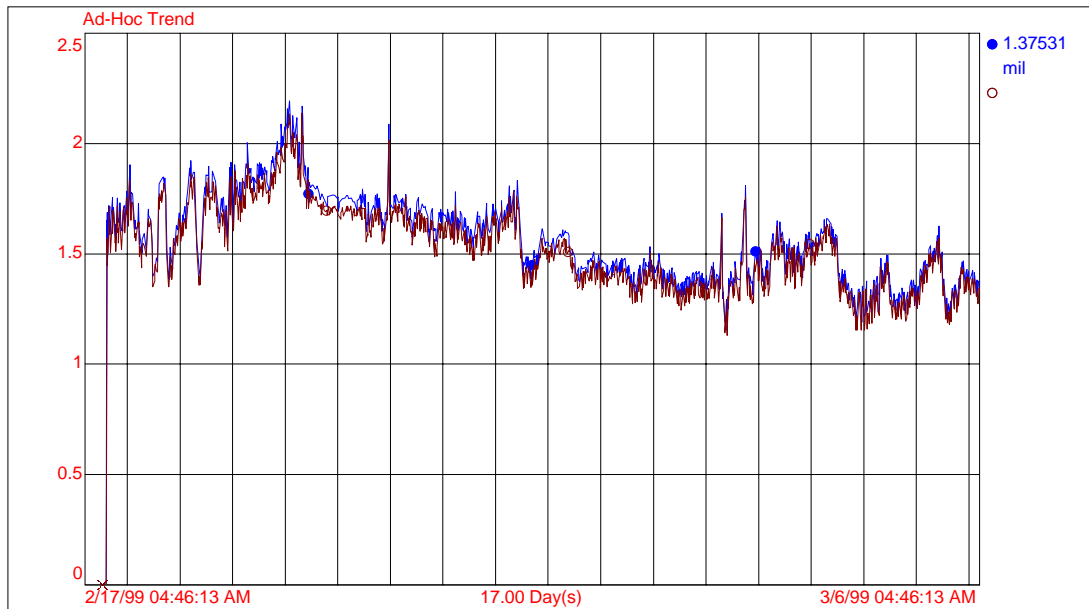
The Fluctuation of vibration level at the Motor Outboard was gradual and initially the vibration amplitudes increased more than 2mils and started reducing, but the fluctuation persisted. The loading cycle of this compressor is normally 4 to 6 hours.

Fig 3. Trend plot of the Motor Outboard Vibration

Fig.3 and Fig.4 show the trend data of the Vibration and bearing temperature at Motor Outboard. The normal Vibration level on this machine is less than 0.7mils-.The Overall Vibration level as well as the bearing temperature is observed more than the normal levels. The Vibration level during the loading went to a maximum of 2.2mils and started falling off, once the load was stabilized.

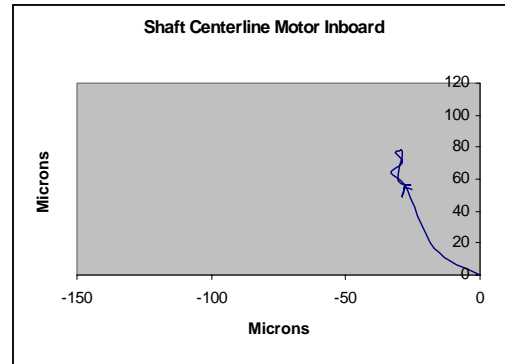
Fig 8. CL including start-up

Fig 8 shows the shaft CL plot at Motor Inboard, where the shaft position is normal compared to the Motor Outboard-Fig 7. The plots of the Compressor bearings were also normal. As the source of the abnormal behavior was obviously pointing towards the outboard bearing, it was decided to open and inspect the Motor Outboard assembly.

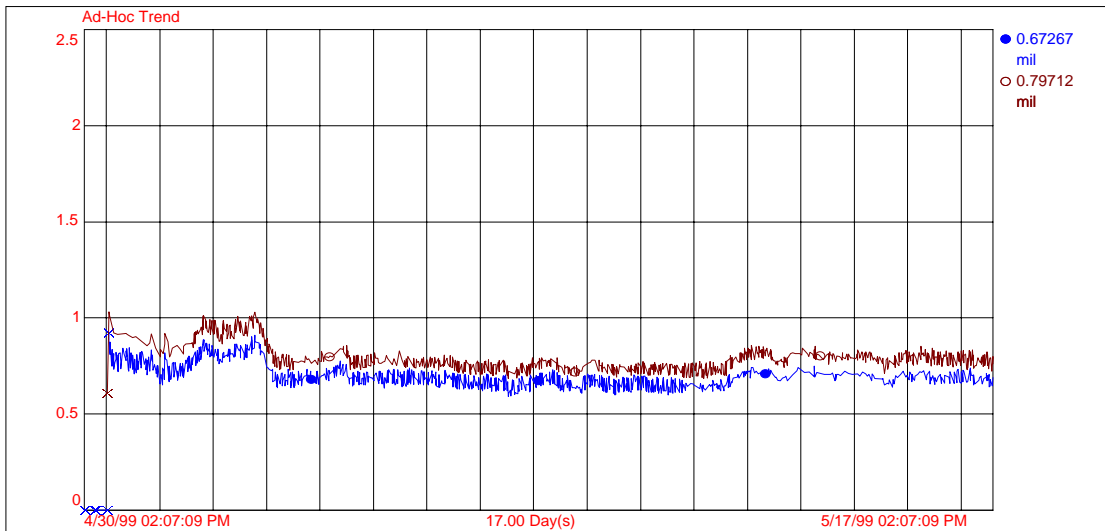
Fig.10 and Fig.11 shows the final vibration and the bearing temperature trend levels. The Vibration levels resumed to normal and the fluctuation also vanished. The Bearing temperature reduced from the 76deg to normal 67 deg.

Fig 10. Vibration trend during final run

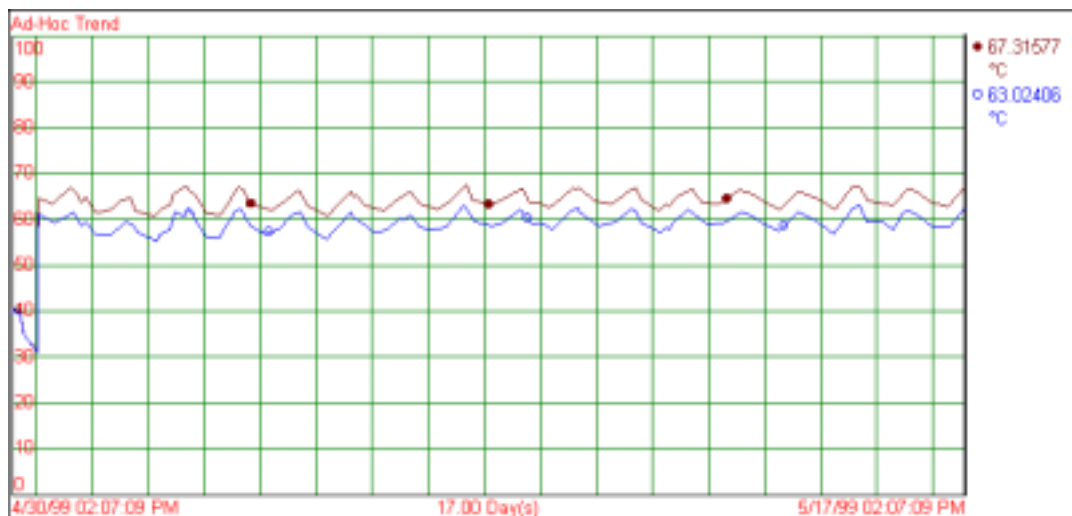
Fig 11. Bearing Temperature trend during final run
