Vibration measurement and diagnosis of valve seat generating machine

History: Customer complains of inaccuracies on the job/ component and high vibrations on the spindle unit assembly

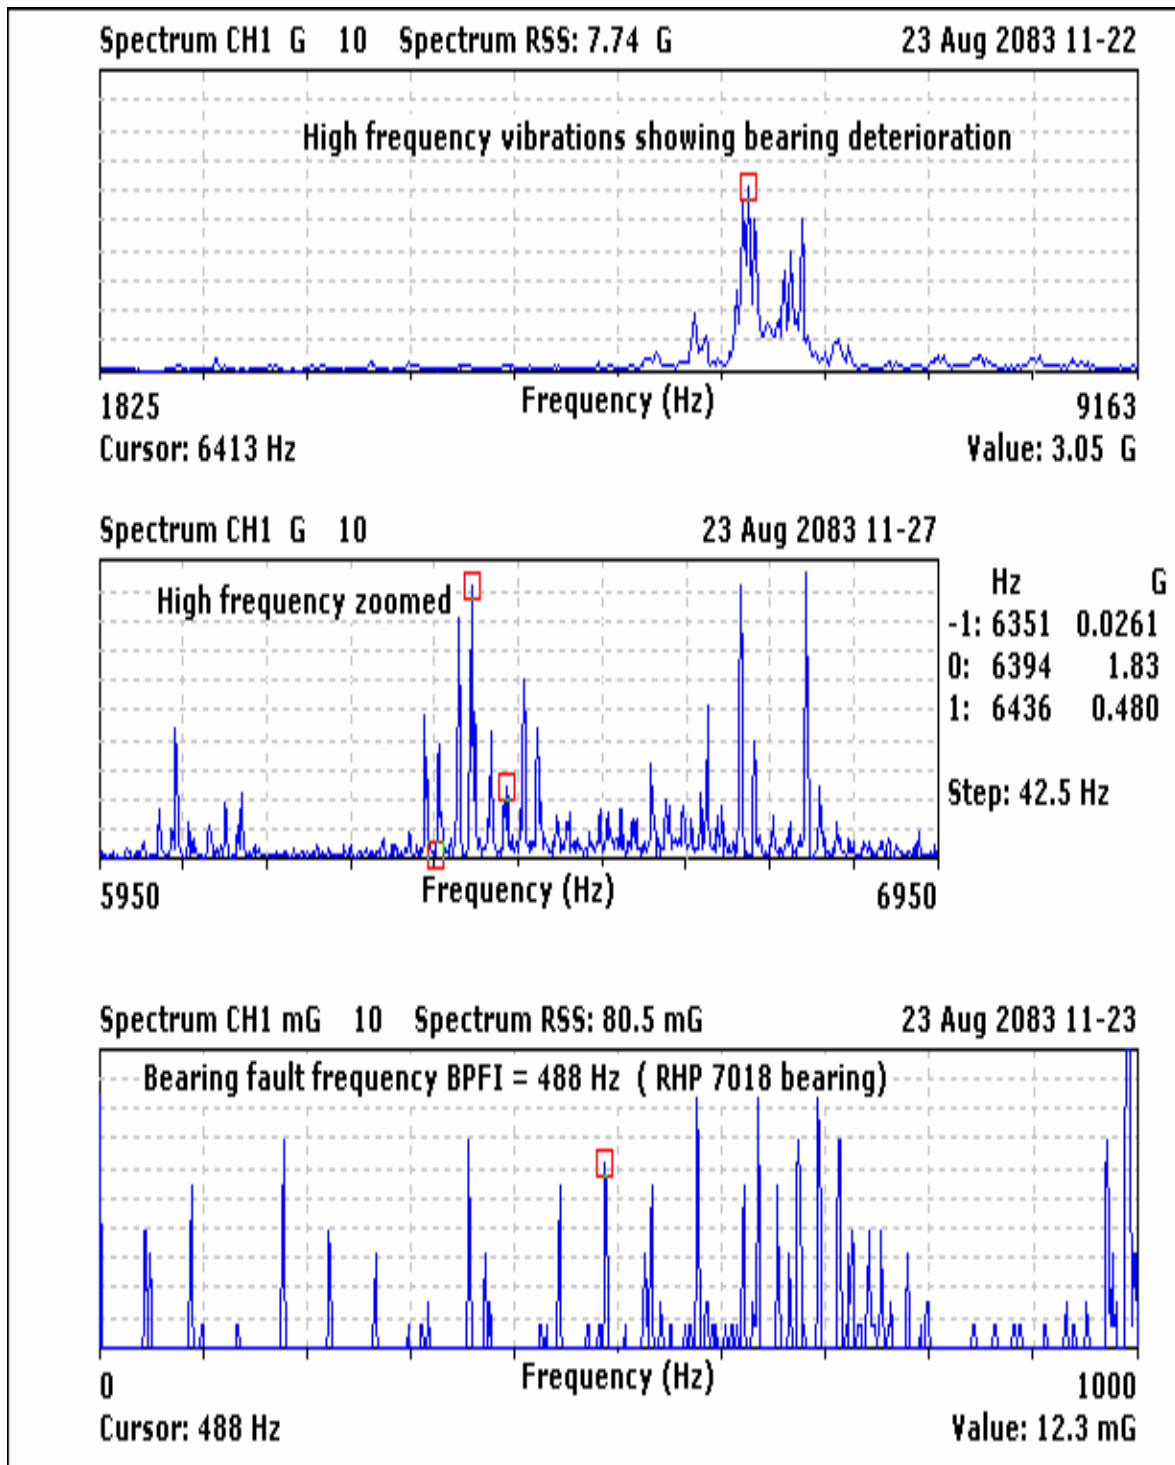
Fig-1 Vibration Spectrum: Inlet Spindle (Front)

- From the measurement & Analysis it was evident that the vibration levels at bearing fault (high frequency 4th band) were very high for both exhaust & inlet spindles.

- It was also evident from the measurement on the spindle that there were remarkable vibrations in all bands for both inlet & exhaust spindles and also side bands with a width of rotational frequency, which indicates bearing deterioration in both spindles.

- From the spectrum analysis it was suspected that the front & rear end bearings in both inlet & exhaust spindles were under deterioration.
- Spindle bearing no. being RHP 7018, bearing fault frequencies were calculated and were correlated with available data. It was seen that bearing fault frequency BPF1 488 Hz was matching with the measured spectrum (Refer Fig-1) also vibration level for that particular frequency was more with harmonics & side bands and concluded as "Bearing is under deterioration".

- It was suggested to replace the bearings of both the spindles
